Manhole Inspection Summary

Manhole # S21MM_016MH

Location Address: **2844 WOODBROOK- REISTERSTOWN ALLEY** Cross Street: **FULTON AVE**

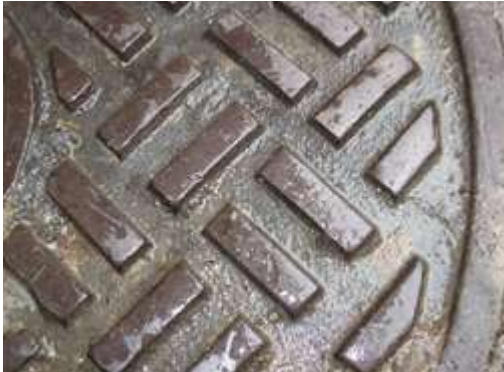
Defect 4

Cover Shape: **Circular** Diameter: **24** (in.) Length: (in.) Dist A/B Grade: **0** (in.)
Type: **Sanitary** Condition: **Cracked** Cover Material: **Cast Iron**
Properties: ☐ Bolted ☐ Vented ☐ Water Tight ☐ Water Tight Insert

LID IS CRACKED

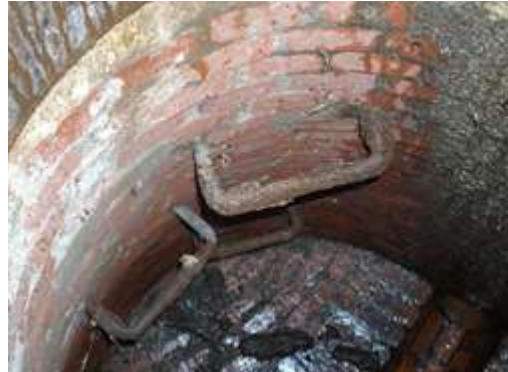
Defect 3

Steps Count: **3** Missing: **0** ☒ **Corroded**

CORRODED STEPS

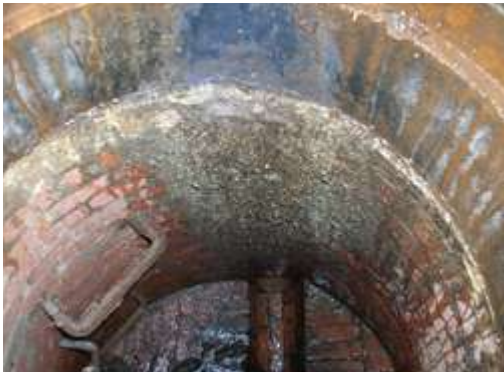
Defect 2

Chimney / Frame Adjustment ☒ Exists Material: **Concrete** ☐ Parged Height: **2** (in.)
Condition: ☒ Sound ☐ Cracked ☐ Root Intrusion ☐ Loose Brick ☐ Deteriorated
Infiltration: ☐ None ☒ **Joint** ☐ Cracks ☐ Mortar ☐ Roots ☐ Wall

INFILTRATION OF JOINT

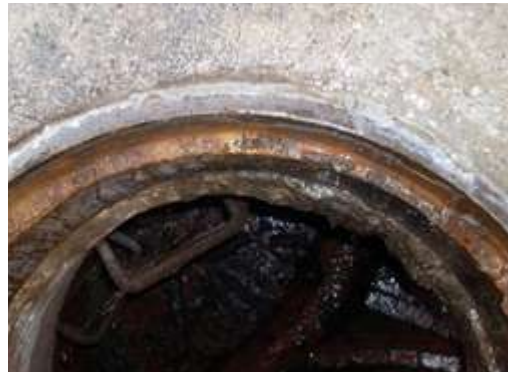
Defect 1

Frame Offset: **1** (in.) Condition: ☒ Sound ☐ Cracked ☐ Leaks

FRAME OFFSET

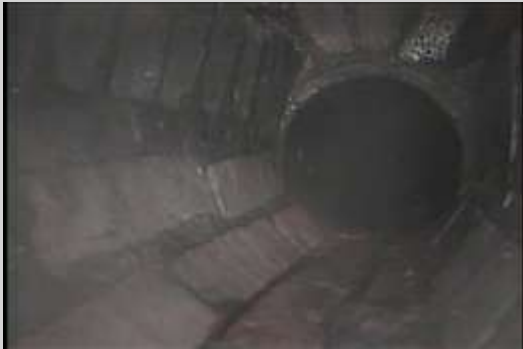
12 O'Clock Outflow

8 in. Circular Gravity Sewer
Pipe Out @ 12 O'Clock

Pipe Height: **8.4** (in.) Rod and Bar (Angled)
Pipe Material: **Clay** ☐ Pipe Lined
Invert Depth: **7.40** (ft.) Flow Characteristics: **Slow**
Deposits: ☒ None ☐ Mud ☐ Sludge ☐ Debris ☐ Grease
Silt Depth: (in.) Deposits Extent:
Infiltration: **None** Pipe Seal Cond: **Sound**

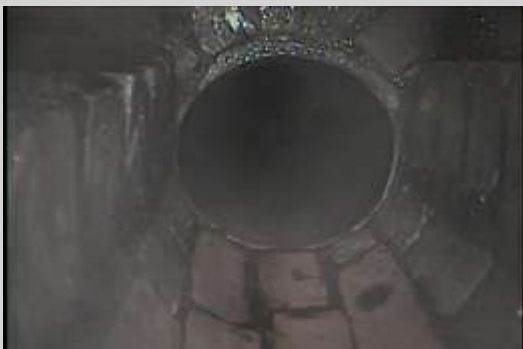
5 O'Clock Inflow

8 in. Circular Gravity Sewer
Pipe In @ 5 O'Clock

Pipe Height: **7.2** (in.) Rod and Bar (Angled)
Pipe Material: **Clay** ☐ Pipe Lined
Invert Depth: **7.02** (ft.) Flow Characteristics: **Slow**
Deposits: ☒ None ☐ Mud ☐ Sludge ☐ Debris ☐ Grease
Silt Depth: (in.) Deposits Extent:
Infiltration: **None** Pipe Seal Cond: **Sound**

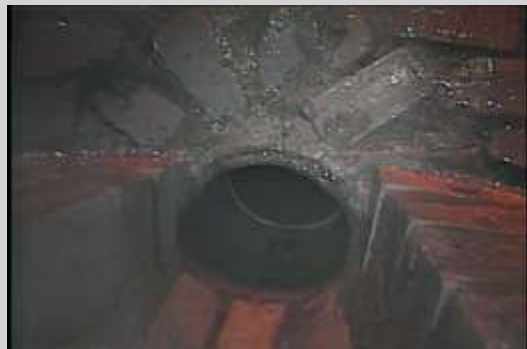
8 O'Clock Inflow

6 in. Circular Gravity Sewer
Pipe In @ 8 O'Clock

Pipe Height: **6** (in.) Rod and Bar (Angled)

Invert Depth: **6.68** (ft.) Flow Characteristics: **None**

Infiltration: **None**

Pipe Seal Cond: **Sound**
